RESURVEY AND INTENSIVE TESTING OF ARCHAEOLOGICAL SITES
AT SAYLORVILLE LAK. (U) IMPACT SERVICES INC MANKATO MN
P M EMERSON ET AL. JUL 83 DACW25-82-C-0068

| REPORT DOCUMENTATION PAGE | | READ INSTRUCTIONS BEFORE COMPLETING FORM |
|---|---|--|
| 4. TITLE (and Subtitle) Resurvey and Intensive Testing of Archaeological Sites at Saylorville Lake, Polk and Dallas Counties, Iowa | | 5. TYPE OF REPORT & PERIOD COVERED Final 9-82 to 7-83 |

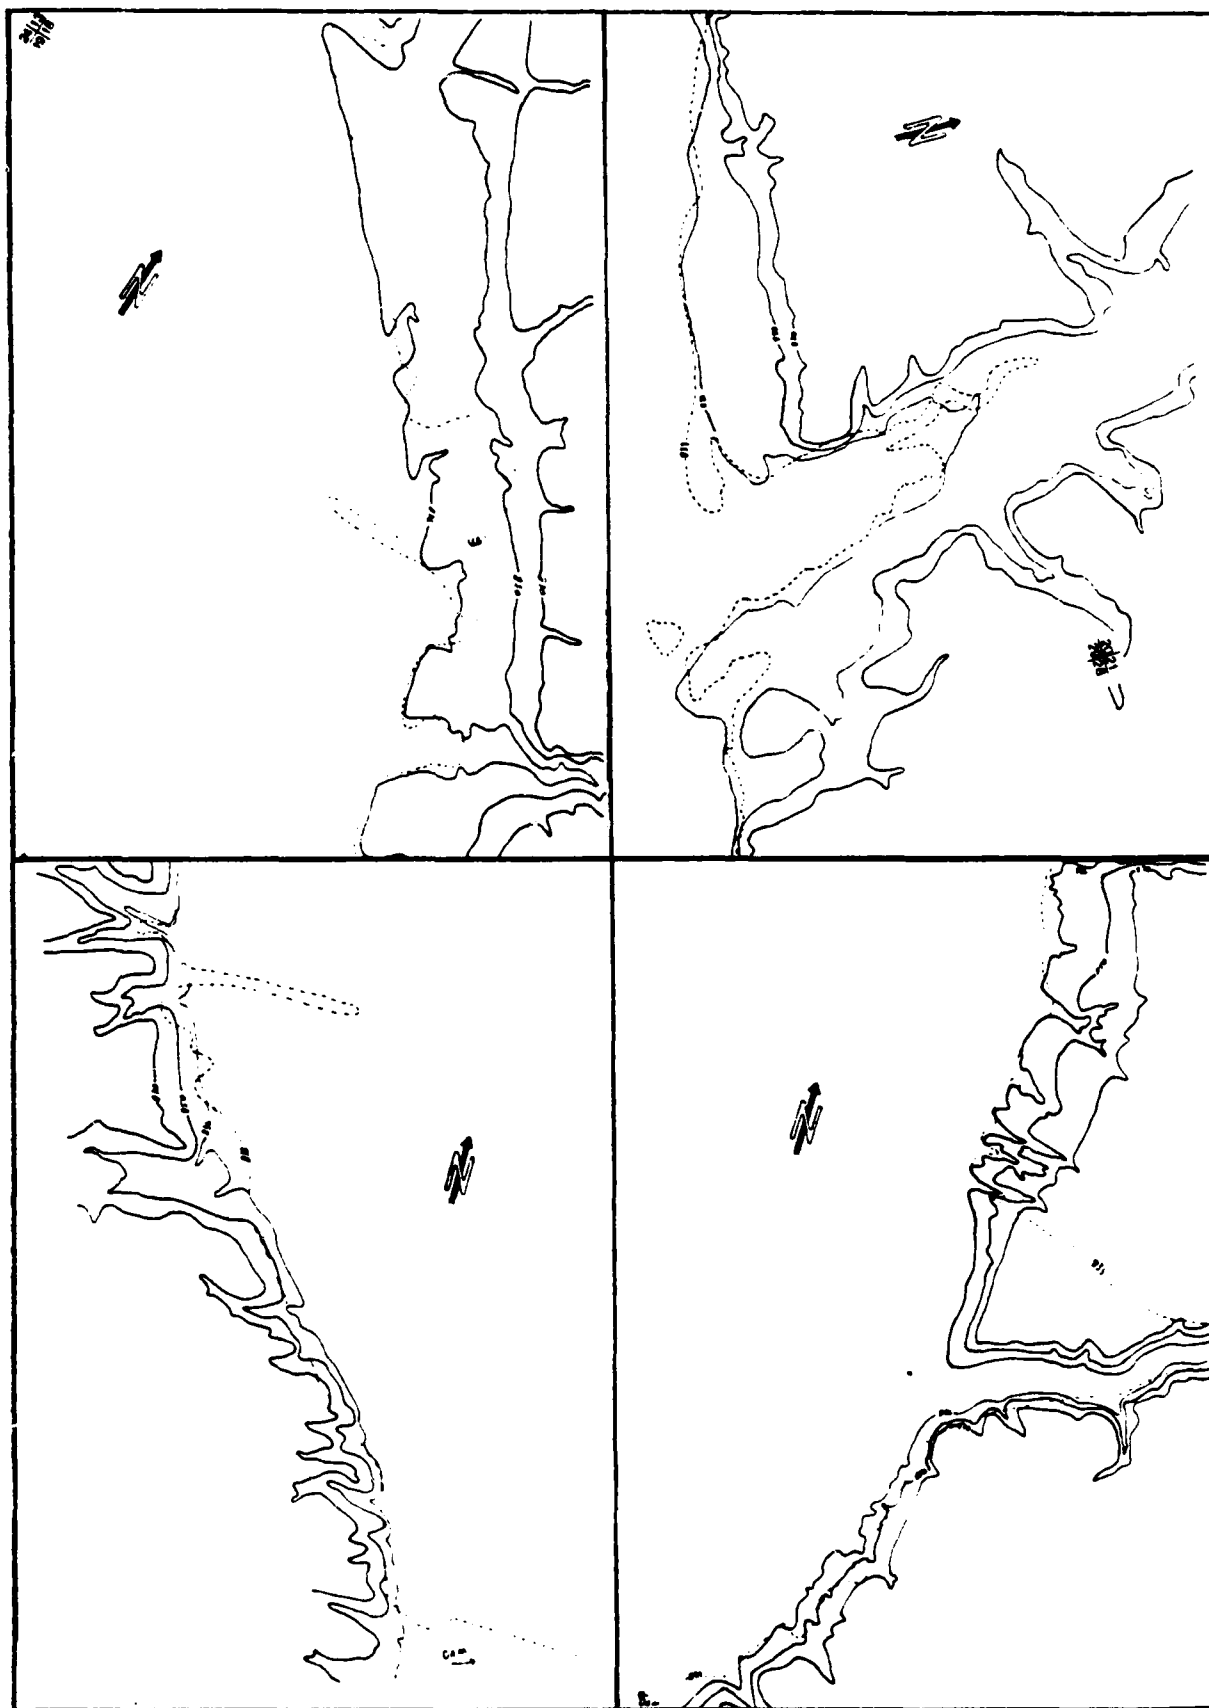
Figure 7. Recent Landscape Alteration at Saylorville Lake

The changes in regional topography reflected in this figure have occurred since 1977, during which time there have been three major high-water episodes and a number of minor fluctuations in lake level. Because the lake is intended to serve as a flood-control reservoir as well as a recreational area, the processes which created the current shoreline will undoubtedly continue to operate in the future. Thus, the probability of attaining a plateau of stability is minimal. Changes in other regional environmental characteristics can also be observed. These changes have occurred - and are occurring - on a macrolevel (long-term changes in biome composition) as well as a microlevel (short-term changes in vegetation resulting from periodic inundation.)
